**Lake Pleasant Aquatic Vegetation Management Plan  
Update, Steuben County, Indiana  
2006**

Prepared for:

December 3, 2006

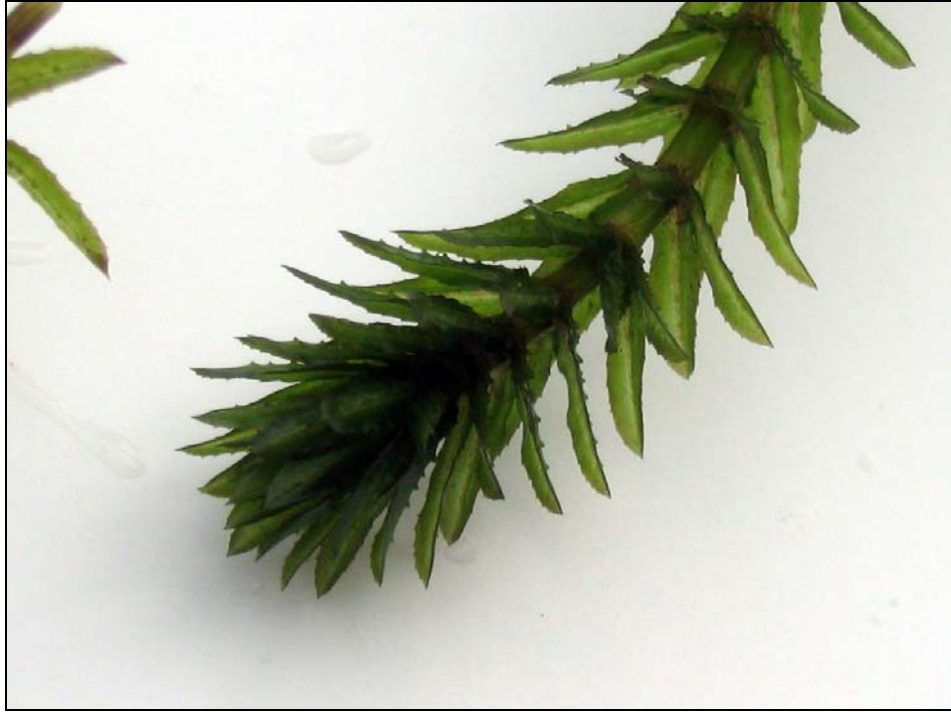
Fig. 32 Edges of Hydrilla leaves have fine serrations visible upon close examination

Hydrilla also has small serrations along the leaf edges (fig 32). Another distinguishing characteristic of Hydrilla is the presence of tubers (.2 to .4 inch long off-white structures attached to the root) (fig 33).

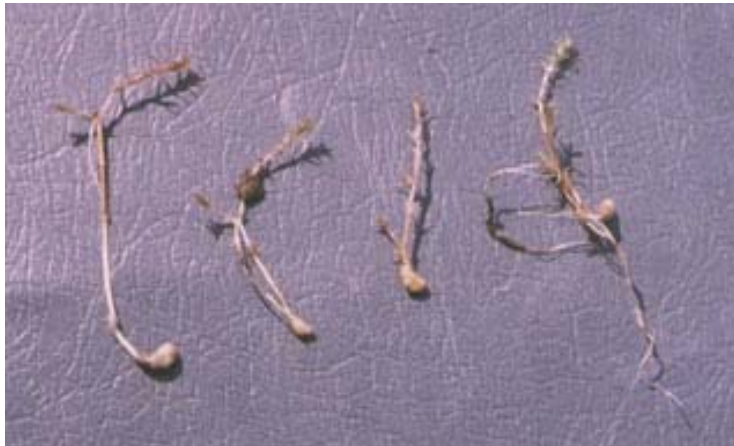
**Fig. 33** Hydrilla plants with tubers attached. Photo courtesy of King County Natural Resources and Parks, Water and Land Resources Division
